Countermeasures to prevent water flowing and to control expansion of water

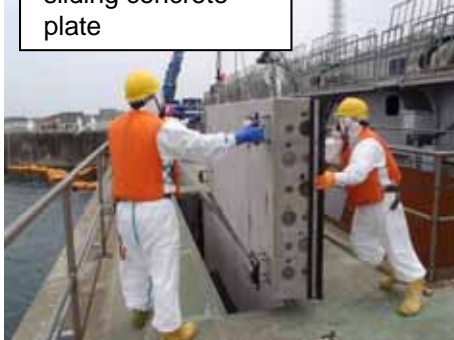
Installation of sliding concrete plate

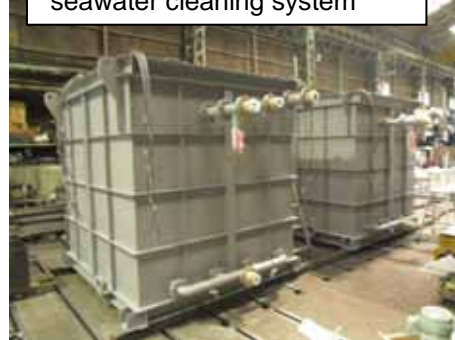
Installation of circulating seawater cleaning system

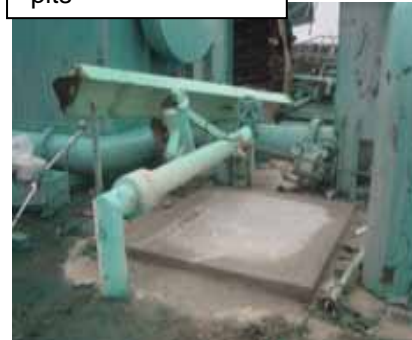
Blockage work at pits

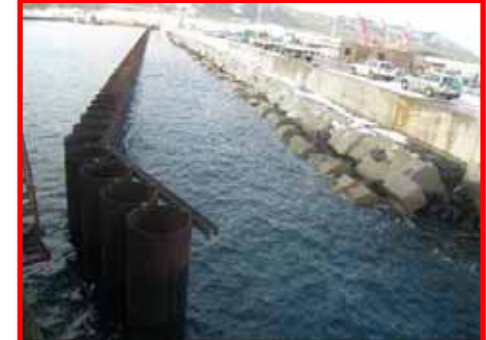
steel sheet pile (Image)

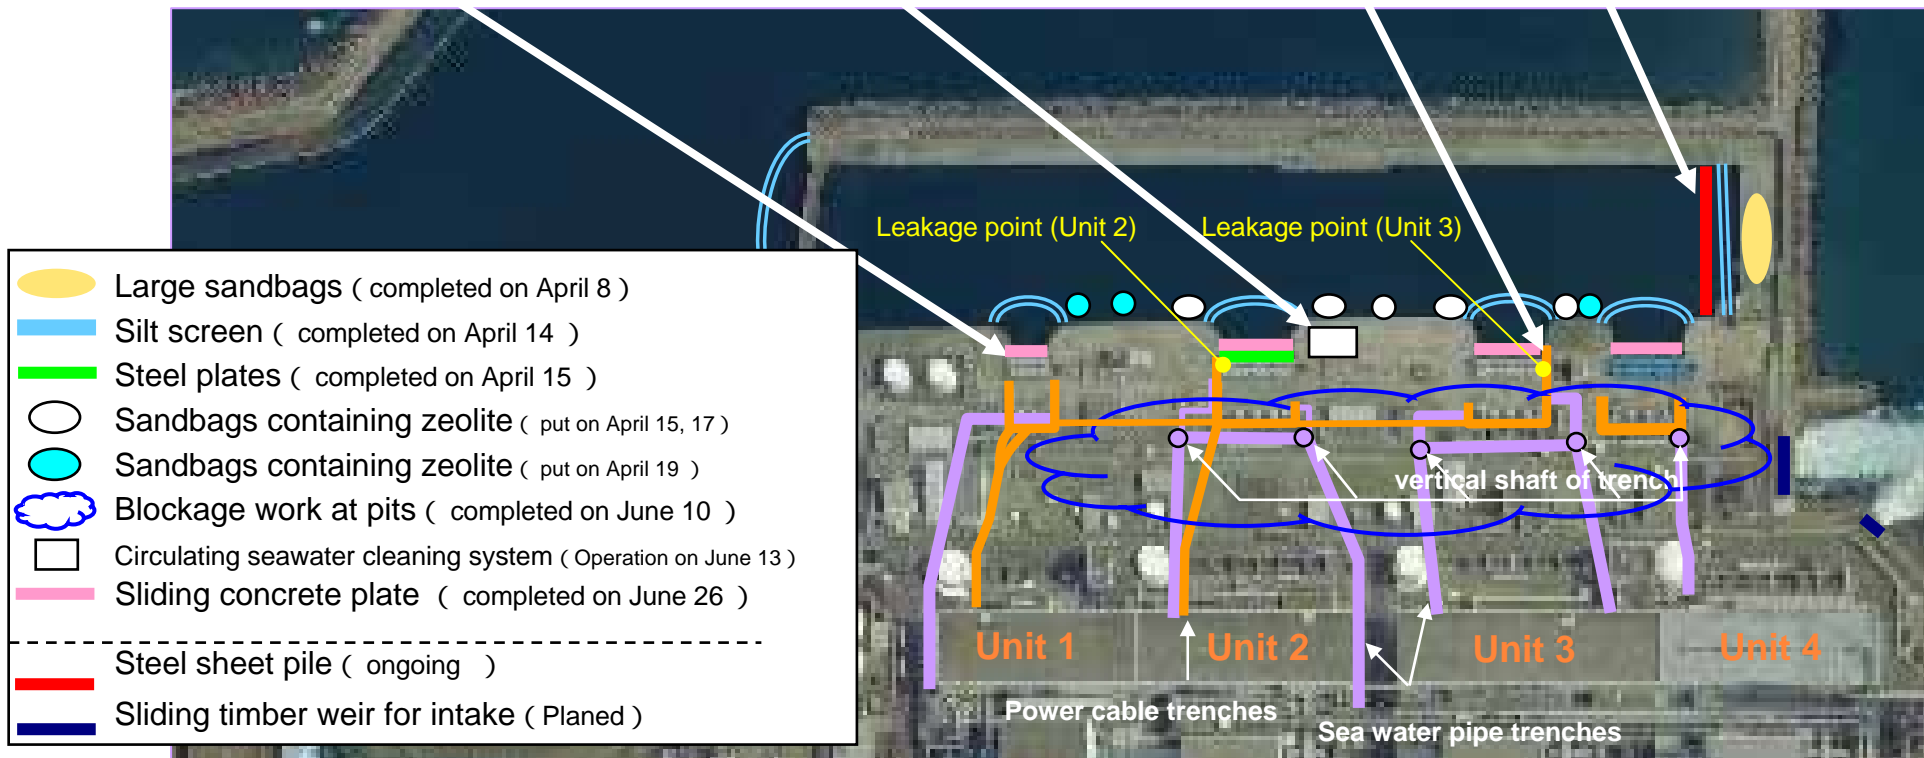
- Large sandbags (completed on April 8)
 - Silt screen (completed on April 14)
 - Steel plates (completed on April 15)
 - Sandbags containing zeolite (put on April 15, 17)
 - Sandbags containing zeolite (put on April 19)
 - Blockage work at pits (completed on June 10)
 - Circulating seawater cleaning system (Operation on June 13)
 - Sliding concrete plate (completed on June 26)
-
- Steel sheet pile (ongoing)
 - Sliding timber weir for intake (Planned)
